**TECHNICAL REPORT**  
**FOR THE**  
**ORDINARY HIGH WATER MARK DELINEATION**  
**OF THE**  
**YELLOWSTONE RIVER**  
**AND**  
**MISSOURI RIVER**  
**(FROM ND/MT BORDER TO WILLISTON, ND)**  
**IN WESTERN NORTH DAKOTA**  
**NOVEMBER 2010**

**TECHNICAL REPORT  
FOR THE  
ORDINARY HIGH WATER MARK (OHWM) DELINEATION  
OF THE  
YELLOWSTONE AND MISSOURI RIVERS IN WESTERN ND  
FOR THE  
NORTH DAKOTA STATE LAND DEPARTMENT  
&  
NORTH DAKOTA OFFICE OF THE STATE ENGINEER**

**NOVEMBER 2010**

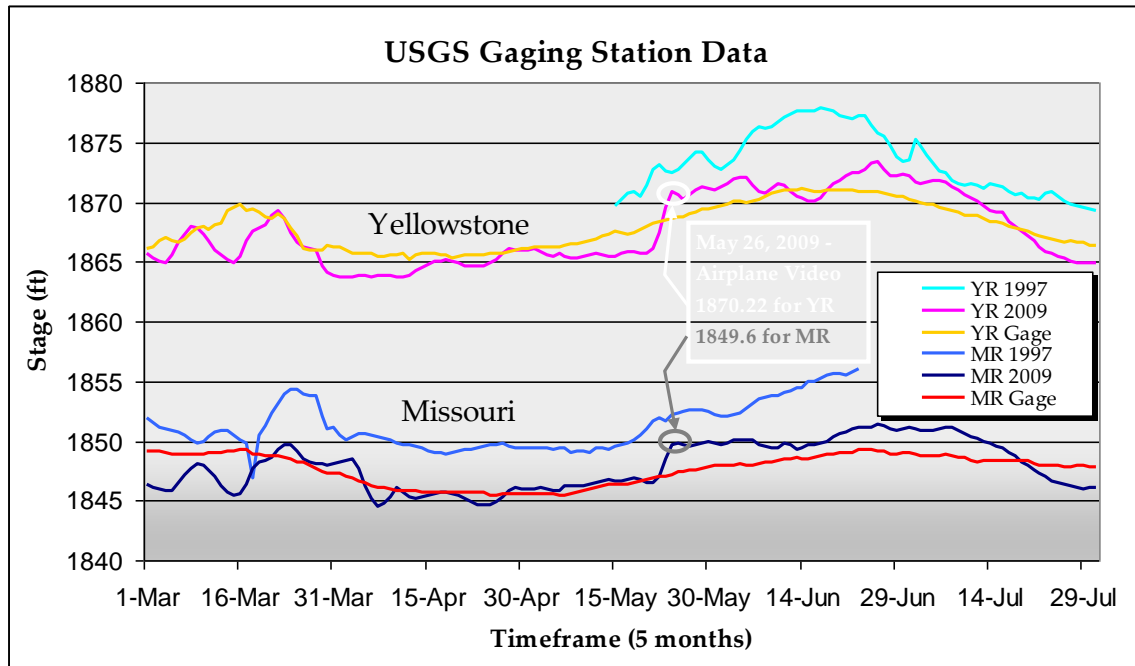
following graph depicts water surface elevations over a 5-month period from March 1<sup>st</sup> – July 31<sup>st</sup>, which is typically when the higher water surface elevations are observed.

The three lines depicted for each river are for the project year 2009, a higher flood year 1997, and then the long term daily average for the period of record, which is 1958-2008 for the Yellowstone River and 1965-2002 for the Missouri River. Also depicted on the graph is the date (May 26, 2009) that a member of the delineation team and the State were able to make a reconnaissance trip in an airplane and capture aerial video and photographs of the two river systems during the spring rise. As one can see, the timing of the flight was right in line with the high average flow for both rivers. This additional information proved invaluable to the delineation team when making their final determinations.

From the graph one can depict the high average daily elevation for the Yellowstone River at Cartwright is approximately 1871 ft-msl (1929 vertical datum). In 2009, the flows in the month of June and into early July were higher than that, which was the reason for the suspension of the fieldwork during this time. The peak water surface elevation for this station, not influenced by ice jams, occurred in mid-June of 1997 with an elevation of 1877.8 ft-msl (1929 vertical datum).

By definition, the OHWM should fall somewhere between the high average elevation and the peak elevation, and likely closer to the high average elevation. Near the gaging station at Cartwright, the surveyed elevations of the OHWM delineation points ranged from 1874.2 – 1874.8 ft-msl (1988 vertical datum). If the data from the USGS is adjusted from the 1929 datum to the 1988 datum, which is +1.8 feet, this would raise the high

average elevation to 1872.8 ft-msl (1988 datum). This indicates that the surveyed OHWM elevations (1874.5 average) near the gaging station fall right in between the 1872.8 (average high) and the 1877.8 (1997 peak) elevations, but closer to the high average elevation.

For the Missouri River gage at Williston, the high average daily elevation is 1849.3 (1929 vertical datum). There is a correction of +1.7 feet to convert to the 1988 vertical datum, which brings the elevation to an even 1851.0 ft-msl. The peak water surface elevation during the period of record occurred in June of 1997, with an elevation of 1856.1 ft-msl (1929 datum). Corrected to the 1988 vertical datum, it would be 1857.8 ft-msl. Similar to the Yellowstone, the OHWM elevations surveyed near the Missouri River gaging station ranged from 1852 –1853 ft-msl (1988 elevation). Once again the OHWM elevations fall between the high average of 1851 and the peak elevation of 1857.8, but much closer to the high average elevation.

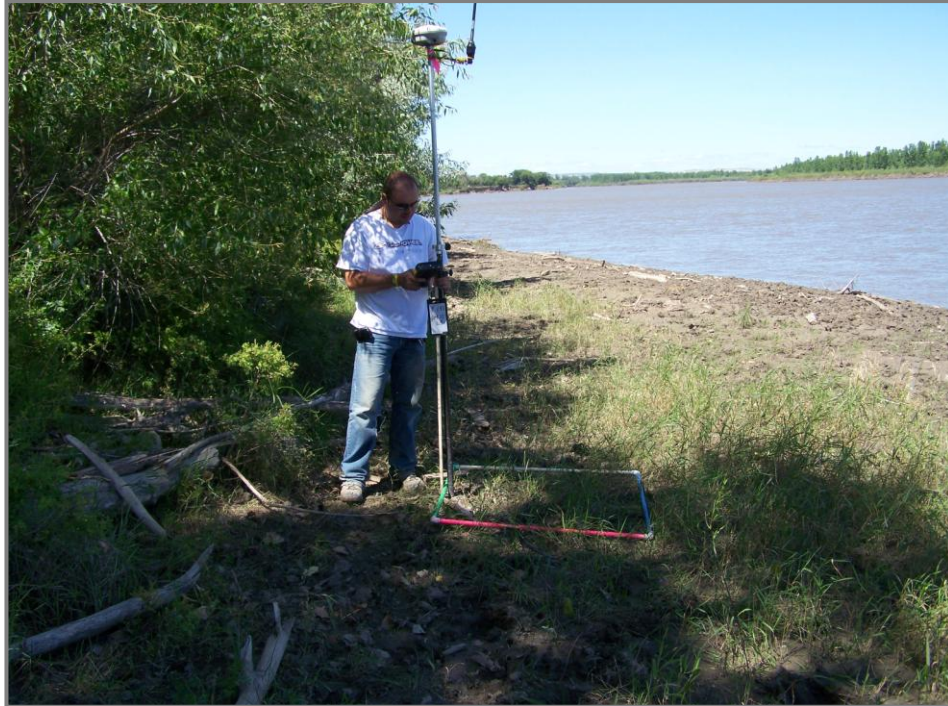
*Figure 2. An example showing a typical downstream facing photo. The quadrat was painted with a separate color for each side. Pink was upstream, white was downstream, green was towards the upland and blue was towards the water.*

For additional documentation and verification, five digital photographs with a resolution of six (6) megapixels were taken at each delineation point transect location; one facing upland (UP), one facing the river (R), one facing upstream (US), one facing downstream (DS), and one overhead of the 1-meter by 1-meter square quadrat (Q) placed on the ground at the OHWM delineation point. Most photographs were taken such that the stake, the transect identifier label, and quadrat location at the OHWM delineation point were also visible in each of the photographs. Electronic copies of these photographs along with the delineation data forms are included in the appendix of the report on a DVD disc and are organized according to the transect identifier.

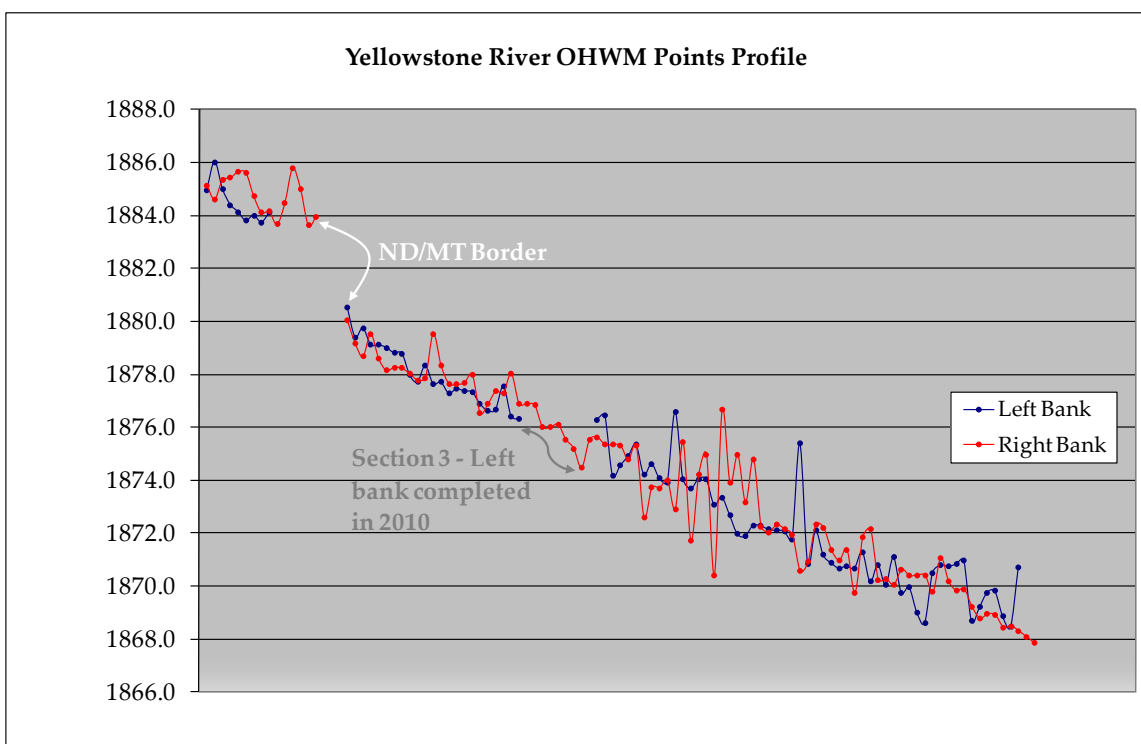
As an additional reference check the delineation point elevations for the utilized points were placed in a spreadsheet and a profile was generated for each river connecting the individual OHWM points. The following two graphs depict this profile, and as one can see, the elevation points generally follow a uniform slope with a few outliers. One must be cognizant of the fact that elevations should only be used as a reference check. All of the elevations shown are Feet-Mean Sea Level and referenced to the NAVD 1988 Datum.

For the Yellowstone River, the reason for the big shift on the left side of the graph is that the profile begins in ND, but then the river flows back into MT for approximately 3.4 miles, before crossing the border back into ND. There are no points depicted for the MT portion of the river. There is also a stretch of river in Section 3 that will need to be completed in the summer of 2010, due to concerns that manmade features may be influencing the OHWM in this area.

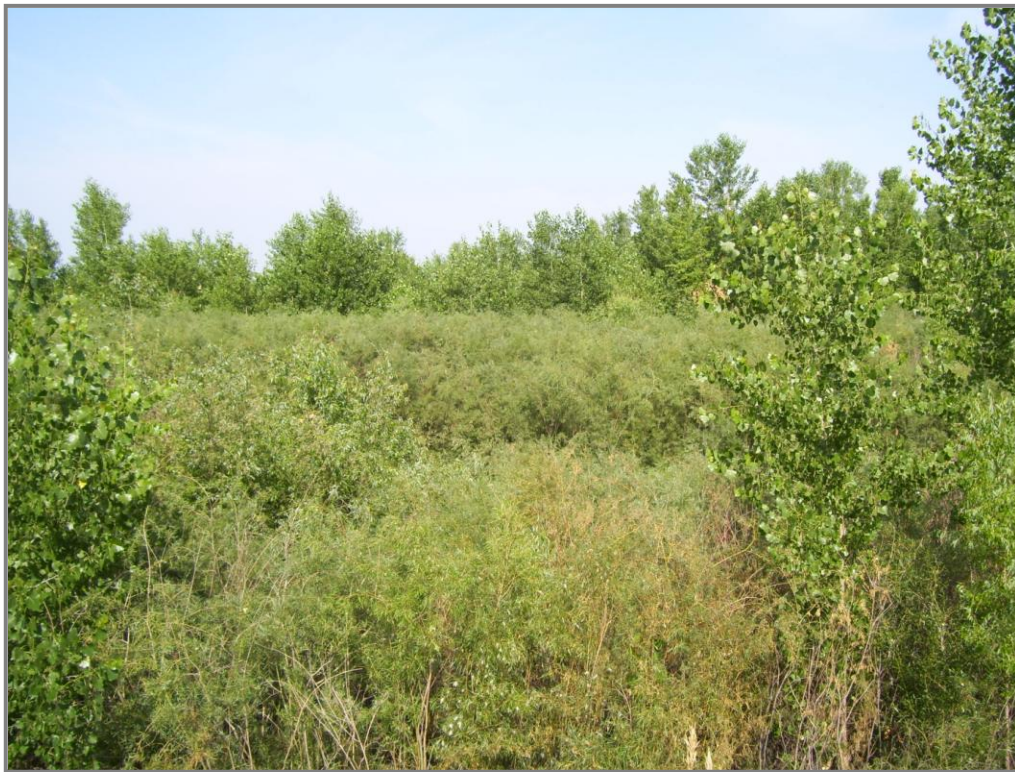
**Figure 4.** Sandbar willow along the right bank of Yellowstone River in Section 23, T151N, R104W. A vertical cut is found along the OHWM. Photo was taken from the upland facing the river. Sandbar willow shrubs are approximately ten feet tall in this area. Understory vegetation is generally lacking.

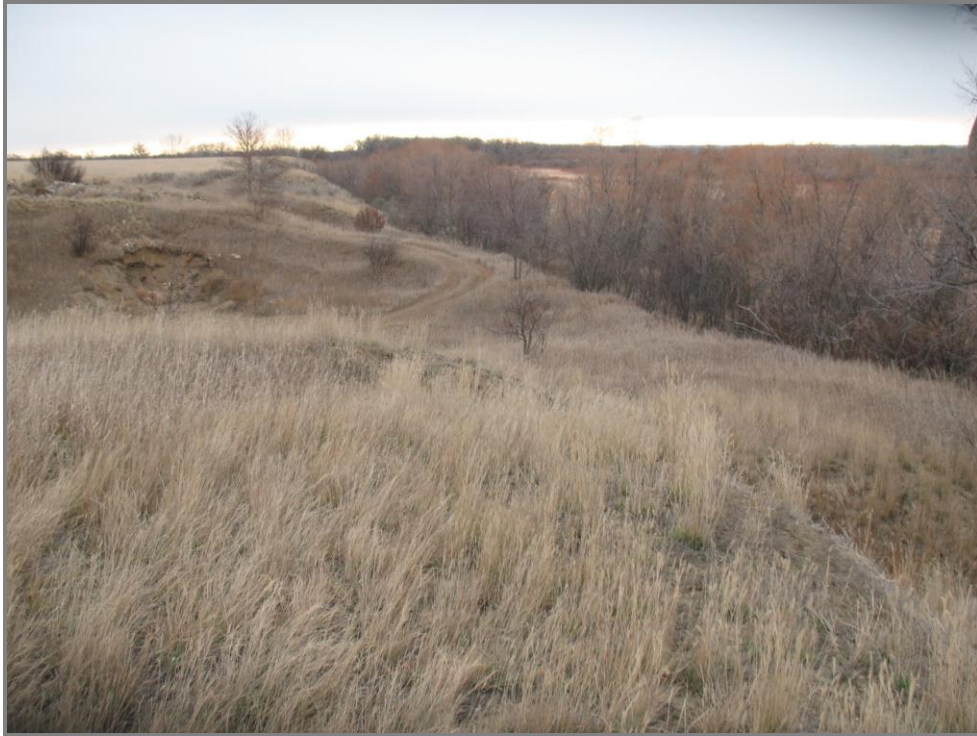
**Figure 5.** Upland and wetland vegetation in Sections 7 and 8 along the left bank of the river. Photo was taken facing east.

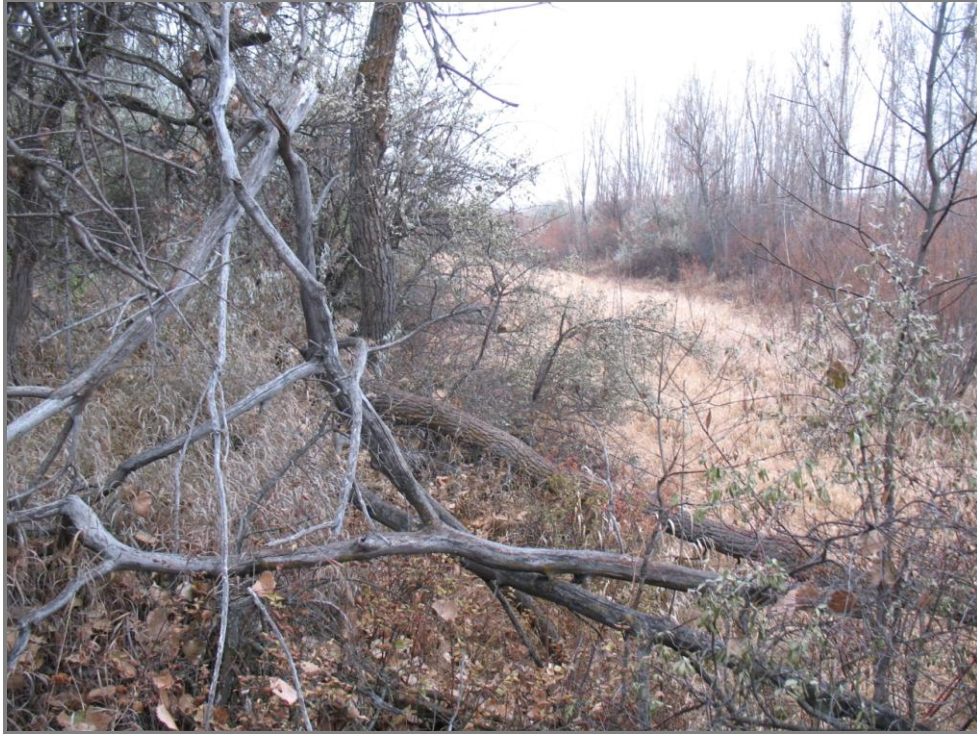
**Figure 6.** Appearance of channel along the OHWM in Section 17. Upland to the left and river to the right. Note Russian olive on levee on bank of channel. Photo was taken facing mostly north (upstream).

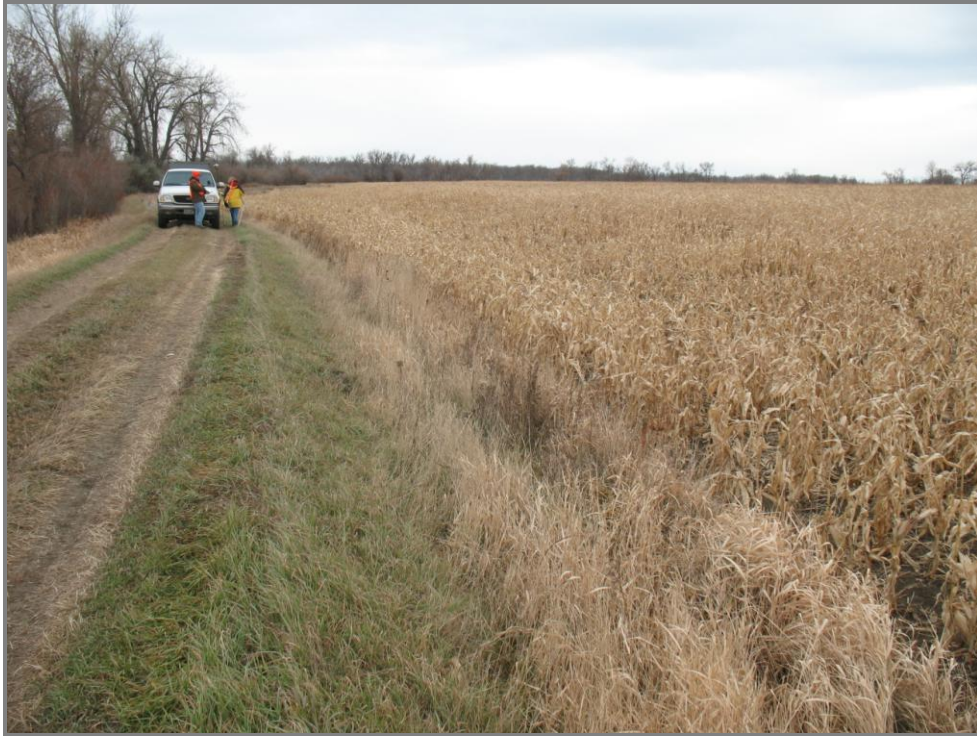
**Figure 7.** Road between the observed OHWM and the upland area. The road likely prevents field runoff from entering the area. Photo taken facing southeast (downstream).

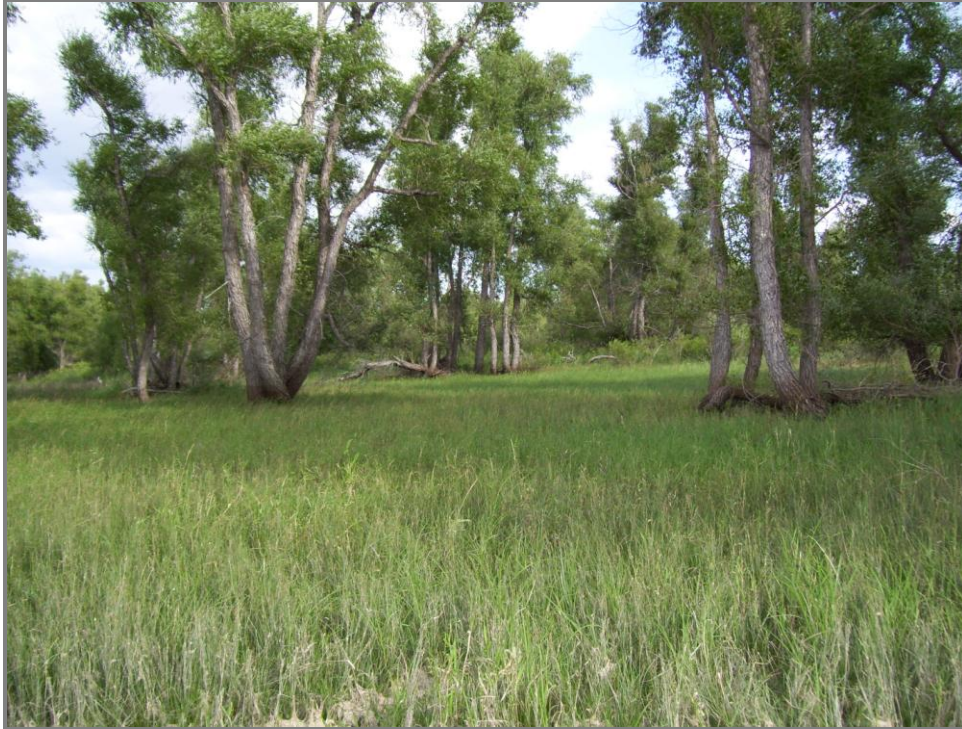
**Figure 8.** Vegetation near the OHWM includes large peach leaf willows with watermarks, understory of wetland vegetation, wrack and matted litter and debris.
